New York Veterinary Specialty and Emergency Center

Patella Luxation

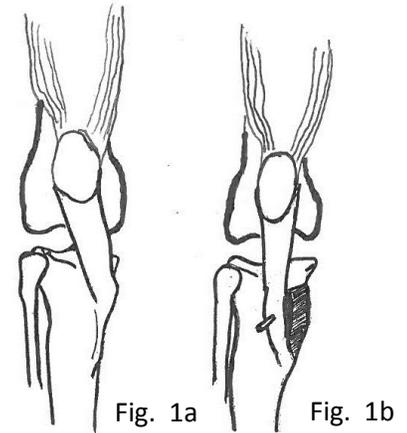
Fig. 1a Fig. 1b
Tibial Crest Transplant to realign the Knee cap

does not go through the groove that the patella rides in it will tend to dislocate. This can be caused by curving of the bones (bowlegged) Fig. 3. or rotation of the point of attachment Fig 1a. Also some dogs stand with a very straight leg and the kneecap rides above the groove (Patella Alta) and is very unstable.

Surgeries should be aimed at correcting the malalignment. The most common case is the tibial crest rotated to the inside Fig. 1a. In this case the crest is detached and moved to the outside and reattached there with pins or wires or both Fig. 1b. If the luxation is lateral (to the outside) then the crest is moved to the inside. For those dogs where the patella rides above the groove often the crest is also moved down as well as outside to pull the kneecap into the groove.

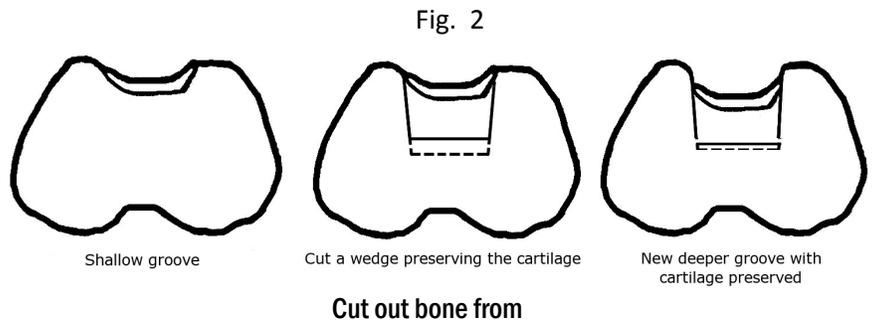
Fig. 2
Cut out bone from

Often the groove is not completely formed and is deepened as part of the repair. This can be accomplished by removing the cartilage and bone to make a rectangular slot which fills in with fibrocartilage. Or a wedge or section of cartilage and bone is lifted and the bed below is deepened and then the bone/cartilage piece is replaced.

This preserves the cartilage and is called a wedge or block trochleoplasty (Fig. 2).

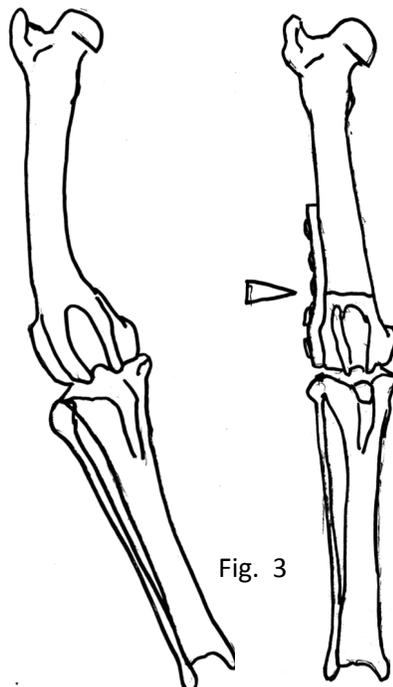
Fig. 3
A wedge of bone is removed to straighten the leg

If the bones of the leg (femur and tibia) are curved or twisted then it is necessary to cut the bones and straighten them out Fig. 3. Bone plates are used to hold them together until the bones heal.

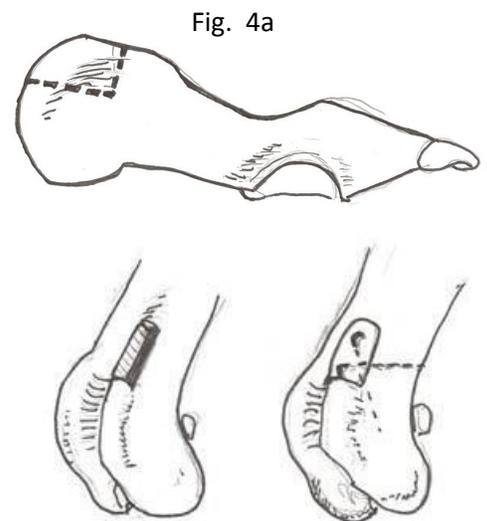
Fig. 4a Fig. 4b
Iliac graft to extend the groove

In some more complicated cases a bone graft is harvested from the pelvis (Fig. 4a) and used to build up the side of the groove (Fig. 4b) where it has been worn down by the luxating patella. In cases of Patella Alta where the tibial crest cannot be advanced this graft can be used to extend the groove.
